# 7. APPENDIX B: Aerial Photographs

## 8. APPENDIX C: Profile Figures

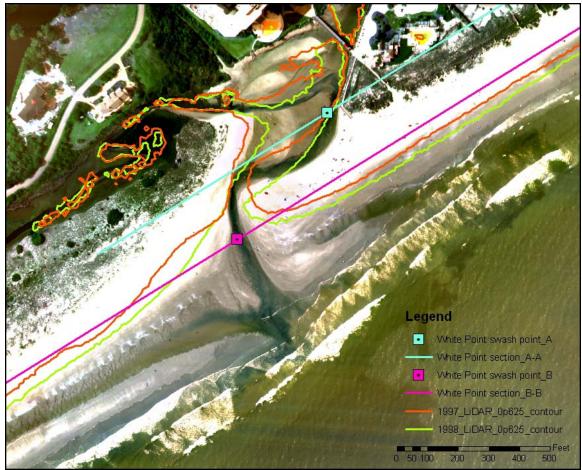
Figure 6-11: +0.625 meter LIDAR elevation contour comparison for 1997 and 1998 at White Point Swash.

0.625 meter	Section A-A		Section B-B	
contour	Distance to	Distance to	Distance to	Distance to
	Right bank	Left Bank	Right bank	Left Bank
LIDAR Date	(meters)	(meters)	(meters)	(meters)
1996	n/a	n/a	-253.8	26.1
1997	-1.7	110.9	-55.2	124.8
1998	-7.5	90.7	-34.3	70.5
1999	-10.5	110.6	-61.6	164.5
2000	-10.8	105.0	-47.3	83.0
2005	-12.8	114.2	-78.0	86.1

Table 6-3: Summary of measured changes to +0.625 meter LIDAR elevation contour at White Point Swash.

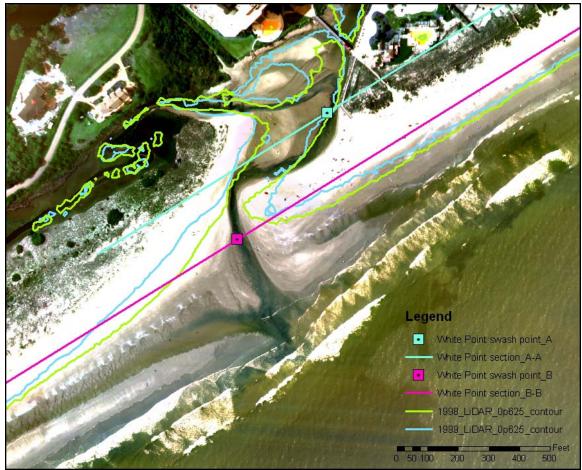
Figure 6-12: +0.625 meter LIDAR elevation contour comparison for 1998 and 1999 at White Point Swash.

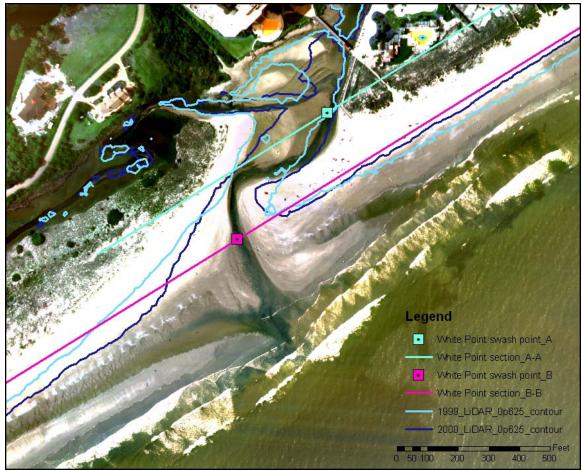
Figure 6-13: +0.625 meter LIDAR elevation contour comparison for 1999 and 2000 at White Point Swash.

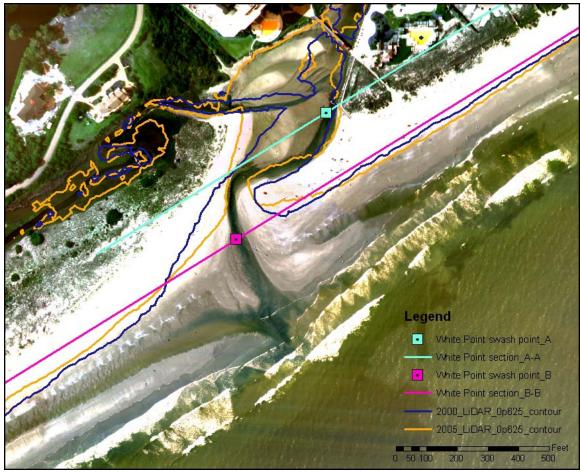
Figure 6-14: +0.625 meter LIDAR elevation contour comparison for 2000 and 2005 at White Point Swash.

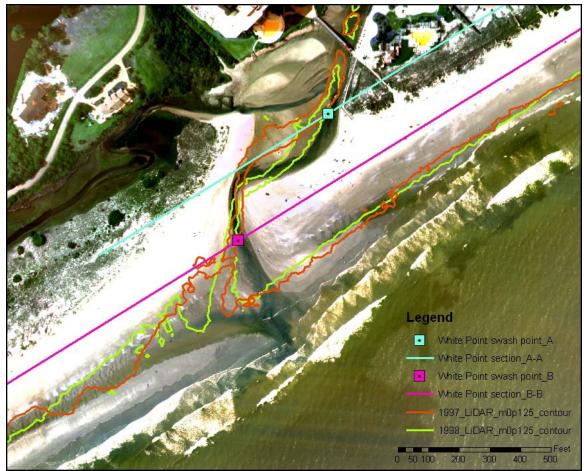
Figure 6-15: -0.125 meter LIDAR elevation contour comparison for 1997 and 1998 at White Point Swash.

-0.125 meter	Section A-A		Section B-B	
contour	Distance to	Distance to	Distance to	Distance to
	Right bank	Left Bank	Right bank	Left Bank
LIDAR Date	(meters)	(meters)	(meters)	(meters)
1996	n/a	n/a	n/a	n/a
1997	11.5	106.8	0	16.0
1998	0	36.7	4.0	18.2
1999	n/a	n/a	-1.2	19.8
2000	-2.1	17.9	-12.1	17.4
2005	n/a	n/a	7.5	13.8

Table 6-4: Summary of measured changes to -0.125 meter LIDAR elevation contur at White Point Swash.

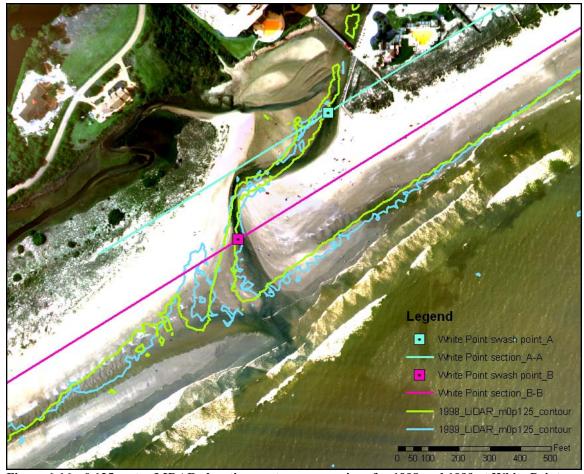
Figure 6-16: -0.125 meter LIDAR elevation contour comparison for 1998 and 1999 at White Point Swash.

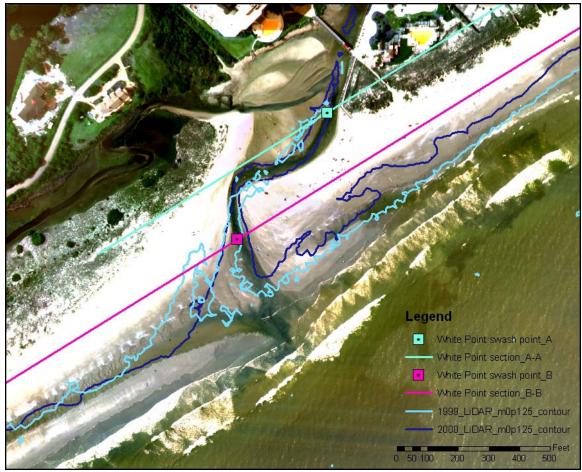
Figure 6-17: -0.125 meter LIDAR elevation contour comparison for 1999 and 2000 at White Point Swash.

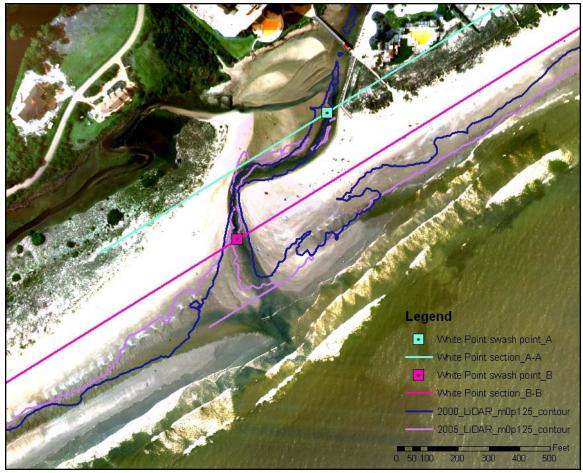
Figure 6-18: -0.125 meter LIDAR elevation contour comparison for 2000 and 2005 at White Point Swash.

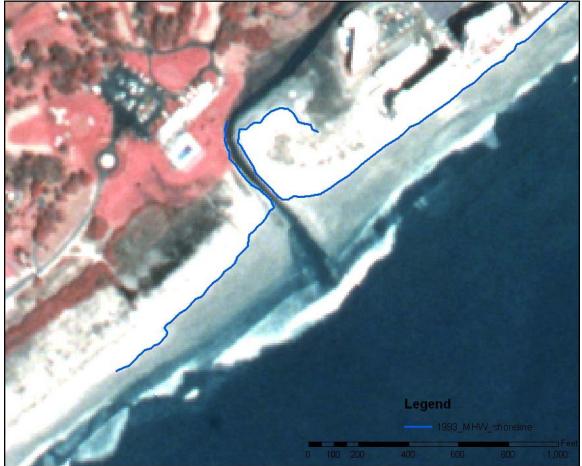
Figure 7-1: 1983 Aerial Photograph at Singleton Swash with approximated MHW line.

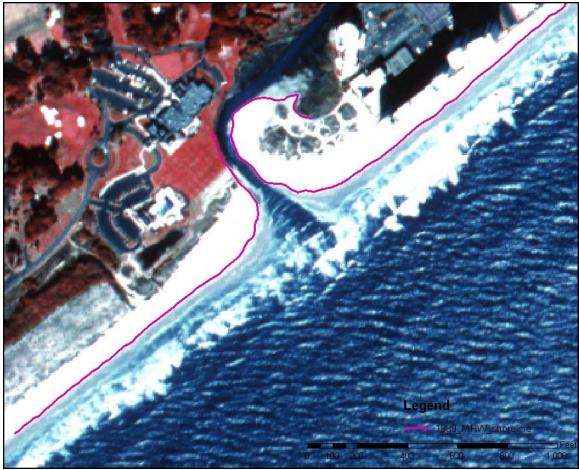
Figure 7-2: 1989 Aerial Photograph at Singleton Swash with approximated MHW line.

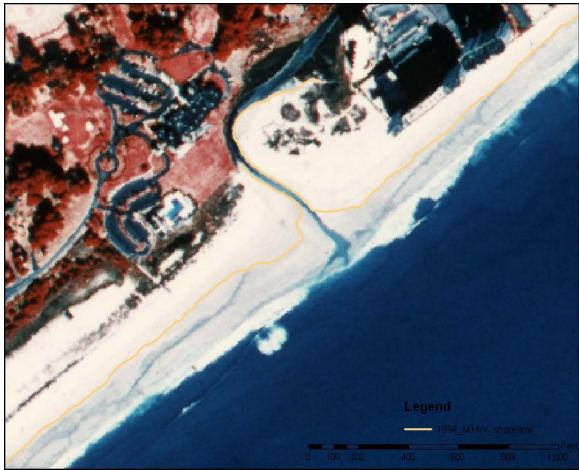
Figure 7-3: 1994 Aerial Photograph at Singleton Swash with approximated MHW line.

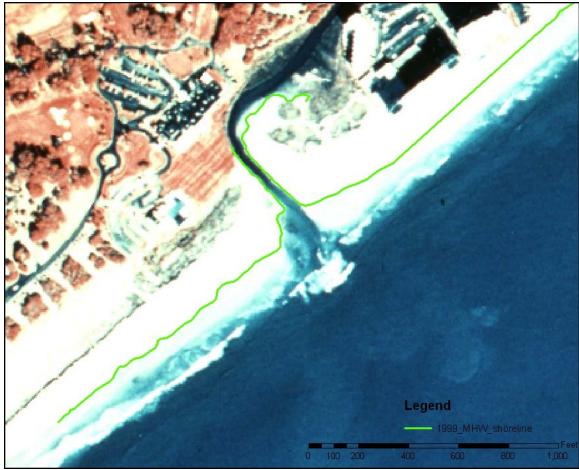
Figure 7-4: 1999 Aerial Photograph at Singleton Swash with approximated MHW line.

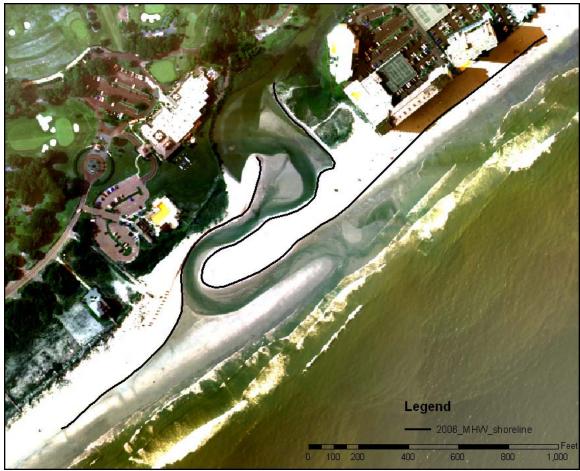
Figure 7-5: 2006 Aerial Photograph at Singleton Swash with approximated MHW line.

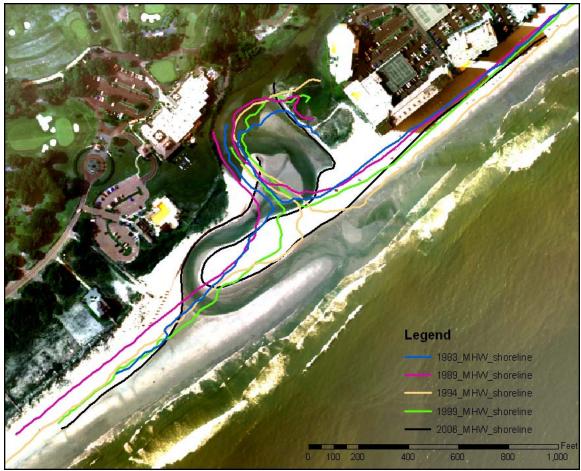
Figure 7-6: Approximated MHW lines at Singleton Swash for 1983-2006 on 2006 Aerial Photograph.

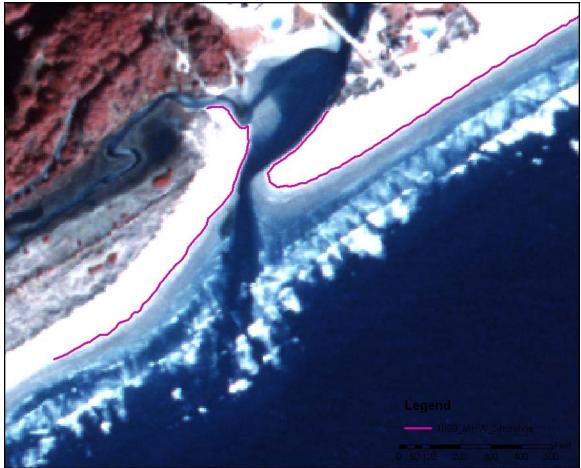
Figure 7-7: 1989 Aerial Photograph at White Point Swash with approximated MHW line.

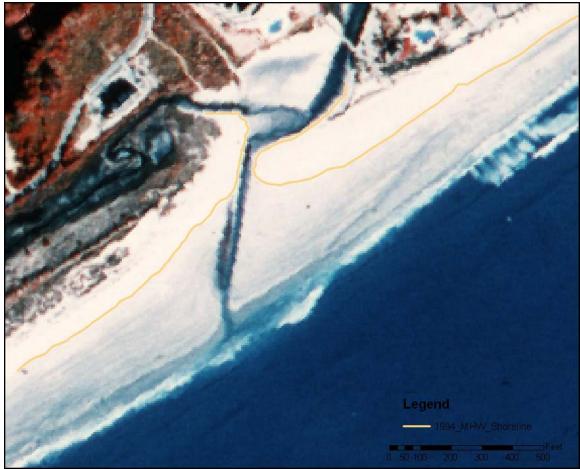
Figure 7-8: 1994 Aerial Photograph at White Point Swash with approximated MHW line.

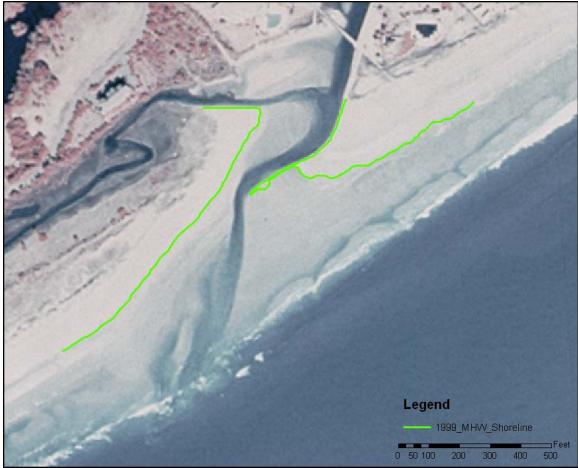
Figure 7-9: 1999 Aerial Photograph at White Point Swash with approximated MHW line.

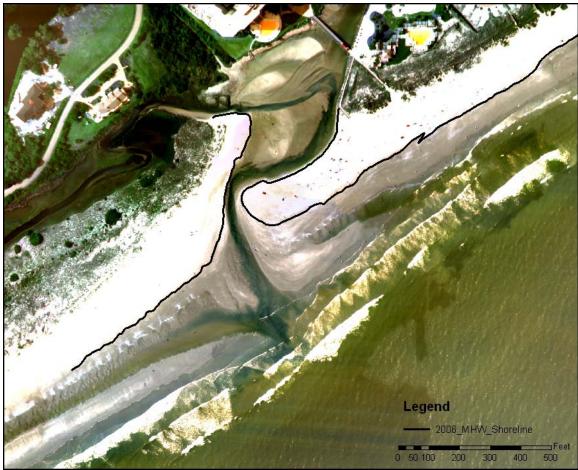
Figure 7-10: 2006 Aerial Photograph at White Point Swash with approximated MHW line.

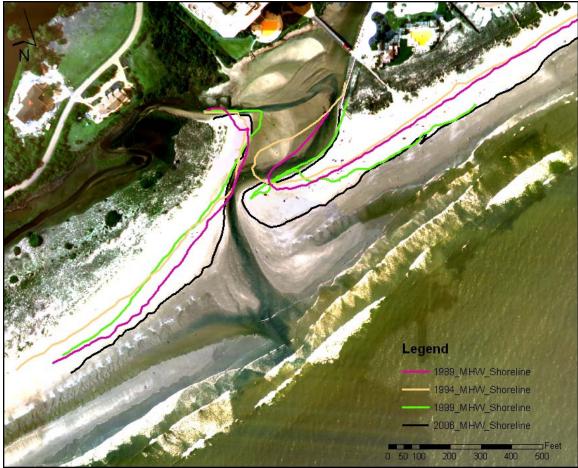
Figure 7-11: Approximated MHW lines at White Point Swash for 1989-2006 on 2006 aerial photograph.

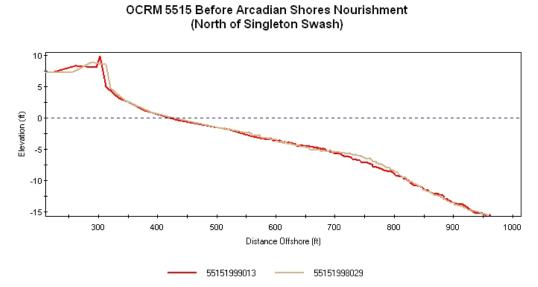
Figure 8-1: Beach profiles north of Singleton Swash at OCRM 5515 prior to Arcadian Shores nourishment project.

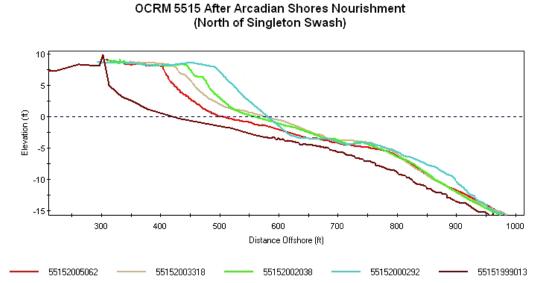
Figure 8-2: Beach profiles north of Singleton Swash at OCRM 5515 after Arcadian Shores nourishment project.

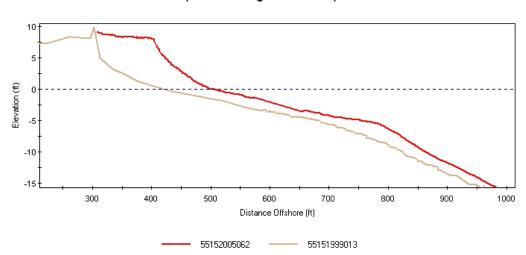
Figure 8-3: Beach profiles north of Singleton Swash at OCRM 5515 prior to and after Arcadian Shore nourishment project.

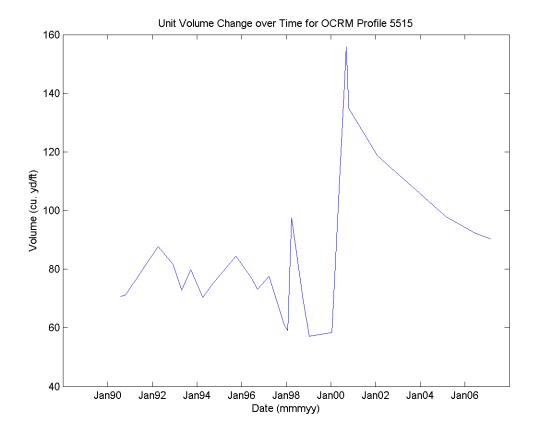
Figure 8-4: Unit Volume Change (cu.yd/ft) over time for OCRM Profile 5515 (North of Singleton Swash).

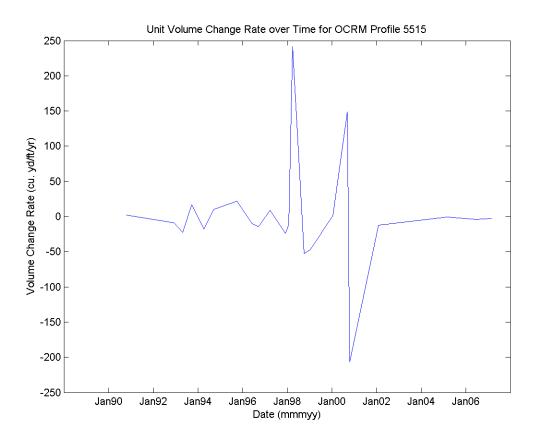
Figure 8-5: Unit Volume Change Rate (cu.yd/ft/yr) over time for OCRM Profile 5515 (North of Singleton Swash).

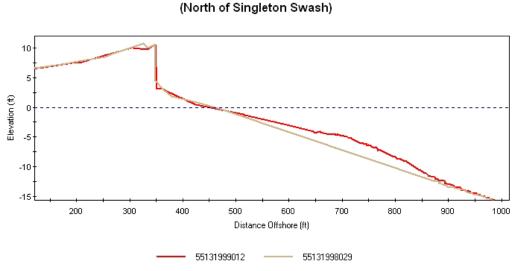
Figure 8-6: Beach profiles north of Singleton Swash at OCRM 5513 prior to Arcadian Shore nourishment project.

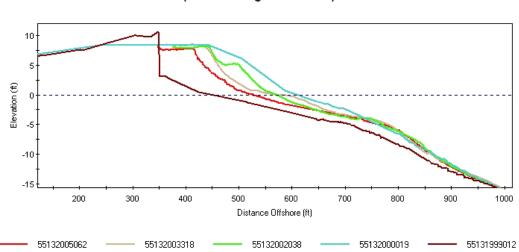
Figure 8-7: Beach profiles north of Singleton Swash at OCRM 5513 after Arcadian Shores nourishment project.

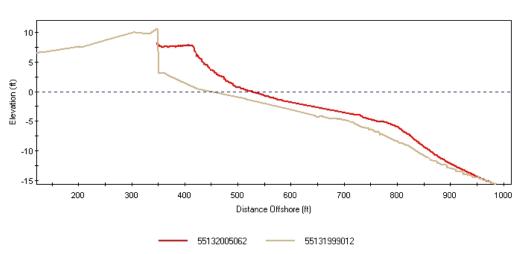
Figure 8-8: Beach profiles north of Singleton Swash at OCRM 5513 prior to and after Arcadian Shore nourishment project.

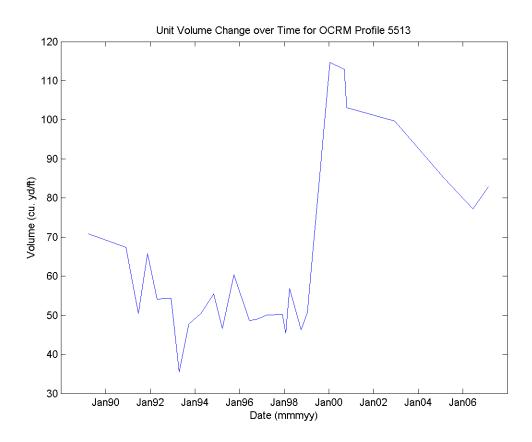
Figure 8-9: Unit Volume Change (cu.yd/ft) over time for OCRM Profile 5513 (North of Singleton Swash).

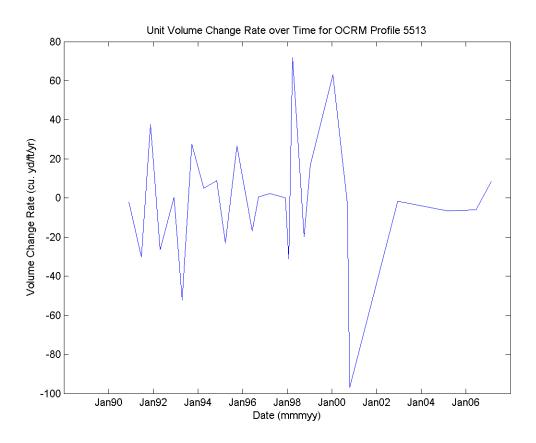
Figure 8-10: Unit Volume Change Rate (cu.yd/ft/yr) for OCRM Profile 5513 (North of Singleton Swash).

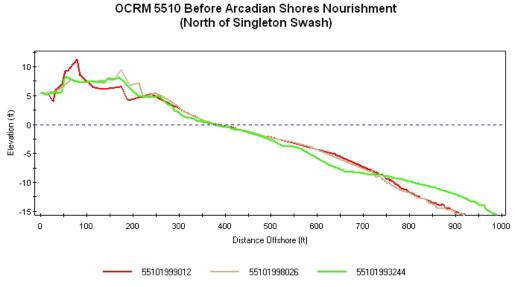
Figure 8-11: Beach profiles north of Singleton Swash at OCRM 5510 prior to Arcadian Shores nourishment project.

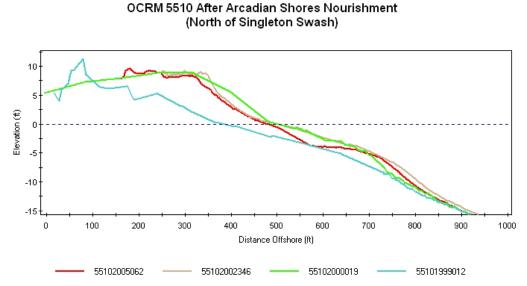
Figure 8-12: Beach profiles north of Singleton Swash at OCRM 5510 after Arcadian Shores nourishment project.

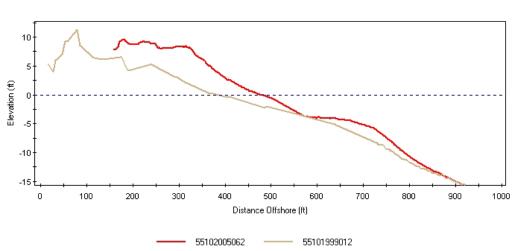
Figure 8-13: Beach profiles north of Singleton Swash at OCRM 5510 prior to and after Arcadian Shores nourishment project.

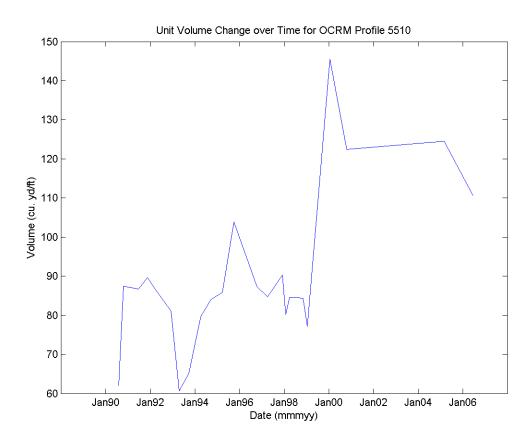
Figure 8-14: Unit Volume Change (cu.yd/ft) over time for OCRM Profile 5510 (North of Singleton Swash).

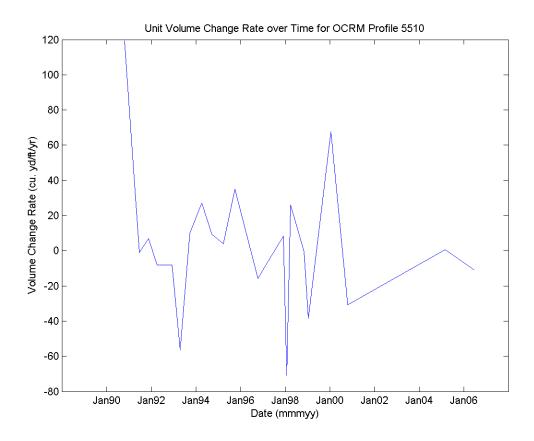
Figure 8-15: Unit Volume Change Rate (cu.yd/ft/yr) over time for OCRM Profile 5510 (North of Singleton Swash).

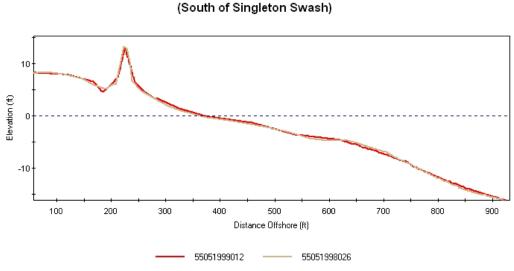
Figure 8-16: Beach profiles south of Singleton Swash at OCRM 5505 prior to Arcadian Shores nourishment project.

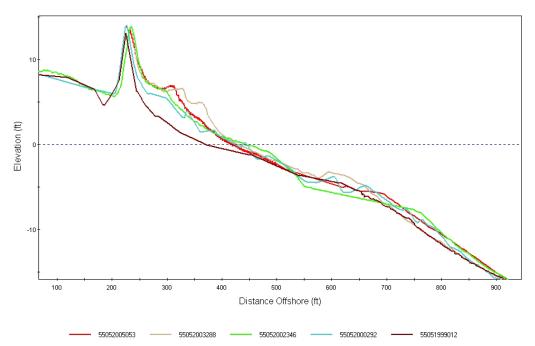
Figure 8-17: Beach profiles south of Singleton Swash at OCRM 5505 after Arcadian Shores nourishment project.

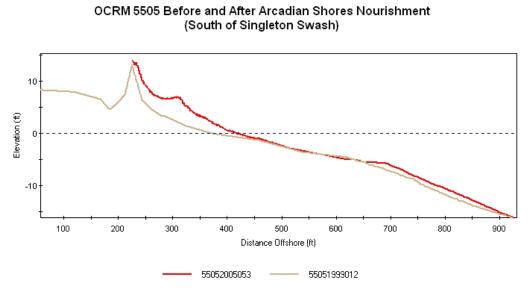
Figure 8-18: Beach profiles south of Singleton Swash at OCRM 5505 prior to and after Arcadian Shores nourishment project.

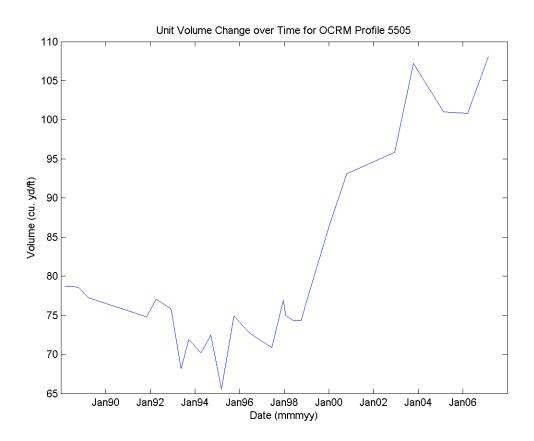
Figure 8-19: Unit Volume Change (cu.yd/ft) over time for OCRM Profile 5505 (South of Singleton Swash).

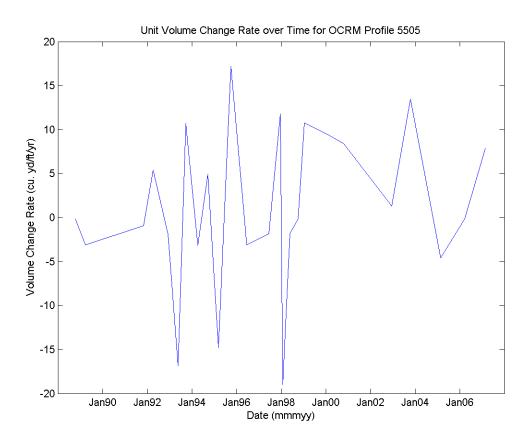
Figure 8-20: Unit Volume Change Rate (cu.yd/ft/yr) over time for OCRM Profile 5505 (South of Singleton Swash).

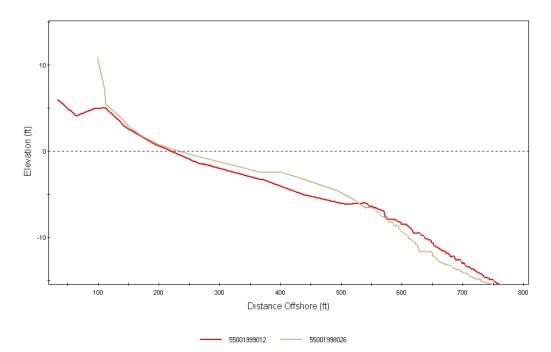
Figure 8-21: Beach profiles south of Singleton Swash at OCRM 5500 prior to Arcadian Shores nourishment project.

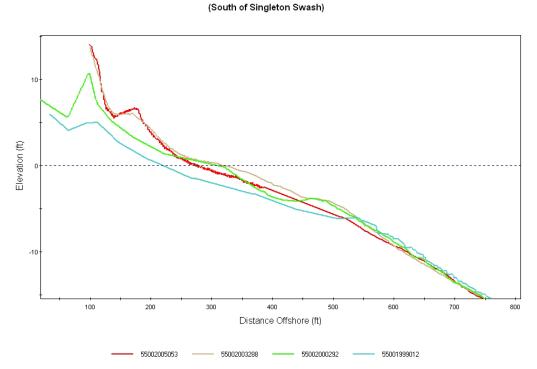
Figure 8-22: Beach profiles south of Singleton Swash at OCRM 5500 after Arcadian Shores nourishment project.

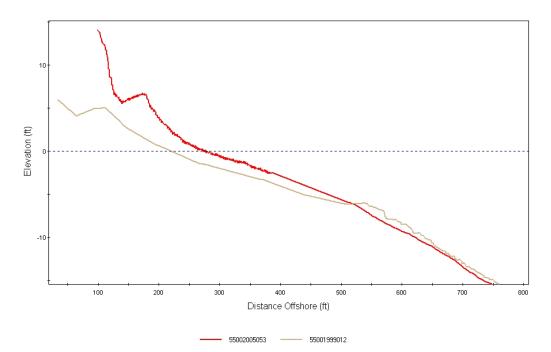
Figure 8-23: Beach profiles south of Singleton Swash at OCRM 5500 prior to and after Arcadian Shores nourishment project.

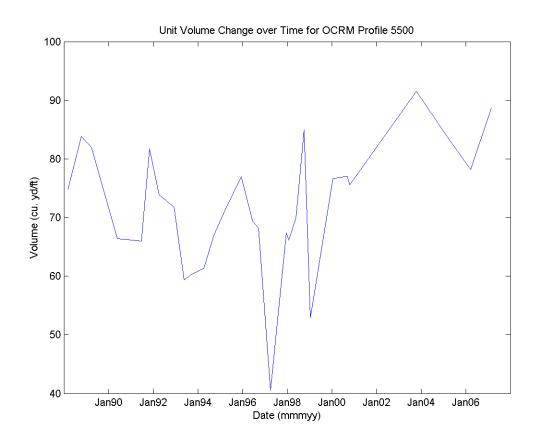
Figure 8-24: Unit Volume Change (cu.yd/ft) over time at OCRM Profile 5500 (South of Singleton Swash).

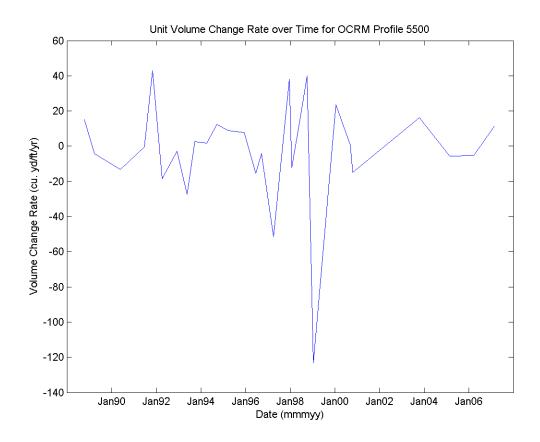
Figure 8-25: Unit Volume Change Rate (cu.yd/ft/yr) over time at OCRM Profile 5500 (South of Singleton Swash).

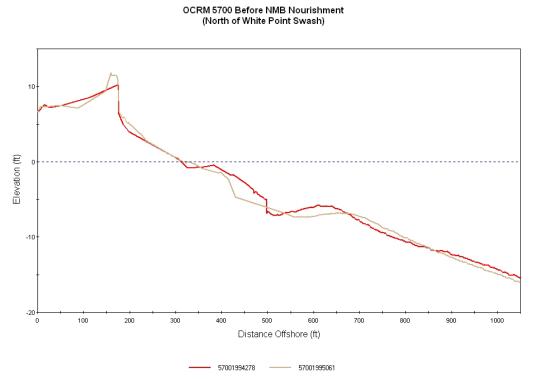
Figure 8-26: Beach profiles north of White Point Swash at OCRM 5700 prior to NMB nourishment project.

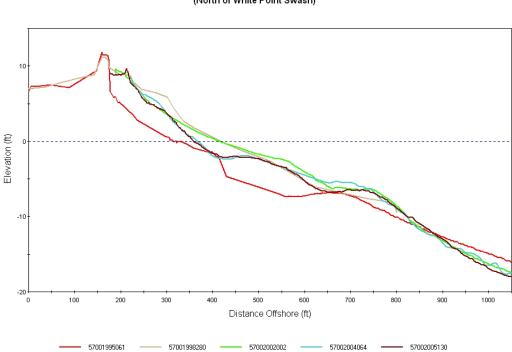
Figure 8-27: Beach profiles north of White Point Swash at OCRM 5700 after NMB nourishment project.

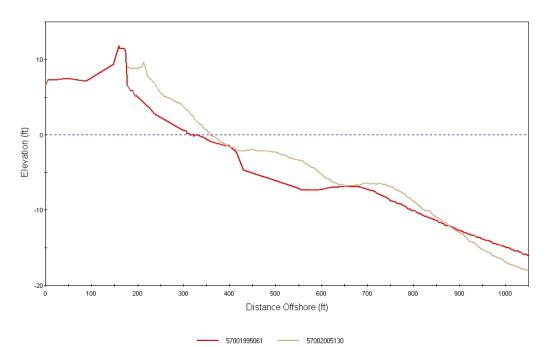
Figure 8-28: Beach profiles north of White Point Swash at OCRM 5700 prior to and after NMB nourishment project.

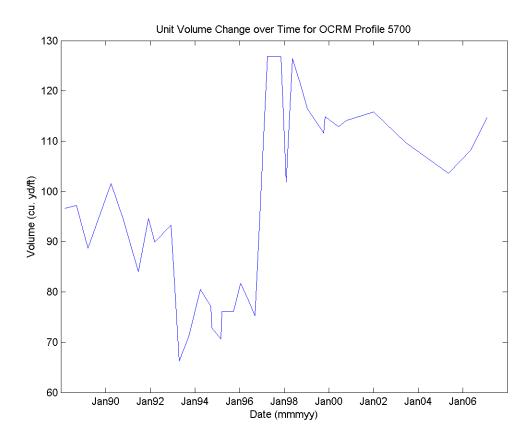
Figure 8-29: Unit Volume Change (cu.yd/ft) over time at OCRM Profile 5700 (North of White Point Swash).

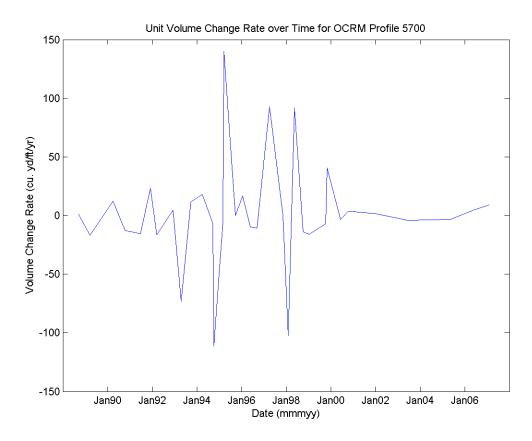
Figure 8-30: Unit Volume Change Rate (cu.yd/ft/yr) over time at OCRM Profile 5700 (North of White Point Swash).

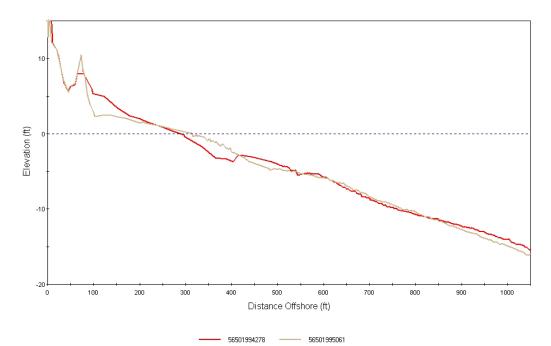
Figure 8-31: Beach profiles north of White Point Swash at OCRM 5650 prior to NMB nourishment project.

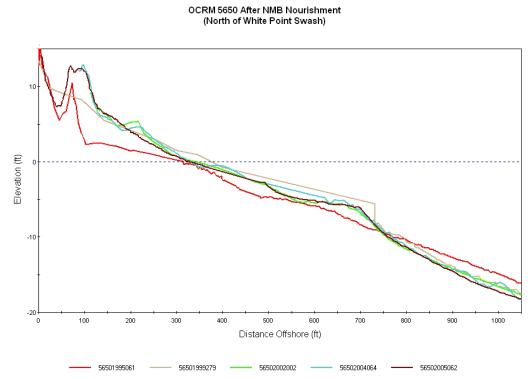
Figure 8-32: Beach profiles north of White Point Swash at OCRM 5650 after NMB nourishment project.

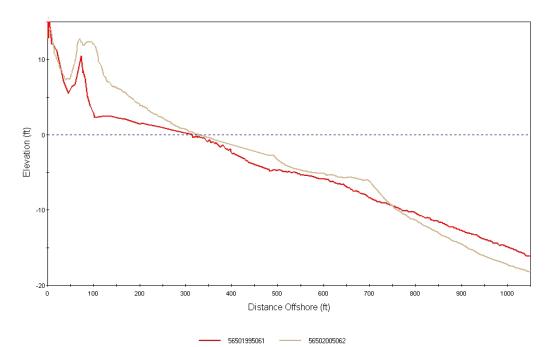
Figure 8-33: Beach profiles north of White Point Swash at OCRM 5650 prior to and after NMB nourishment project.

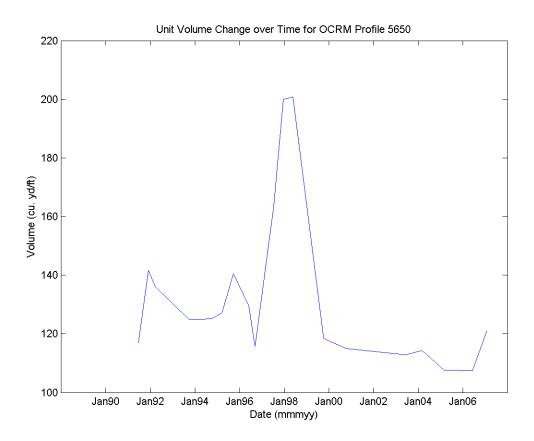
Figure 8-34: Unit Volume Change (cu.yd/ft) over time at OCRM Profile 5650 (North of White Point Swash).

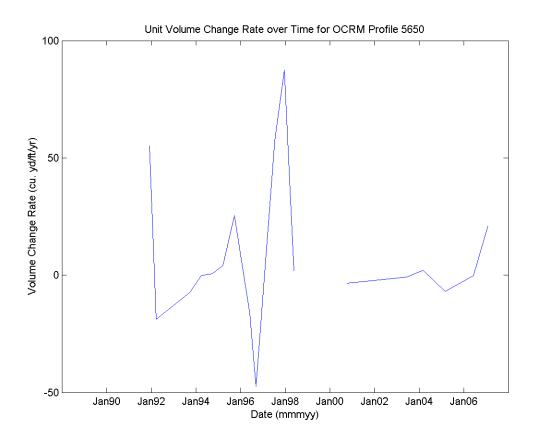
Figure 8-35: Unit Volume Change Rate (cu.yd/ft/yr) over time at OCRM Profile 5650 (North of White Point Swash).

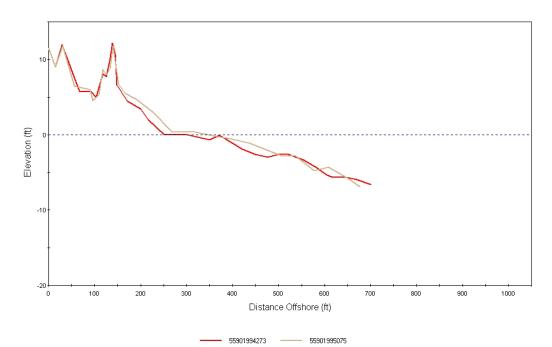
Figure 8-36: Beach profiles south of White Point Swash at OCRM 5590 prior to NMB nourishment project.

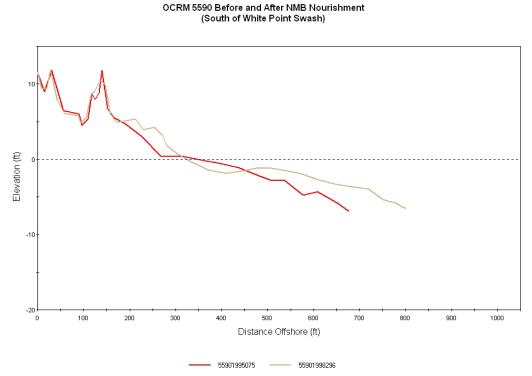
Figure 8-37: Beahc profiles south of White Point Swash at OCRM 5590 prior to and after NMB nourishment project.

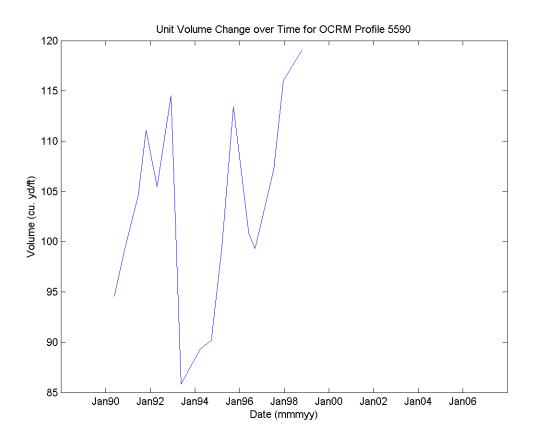
Figure 8-38: Unit Volume Change (cu.yd/ft) over time at OCRM Profile 5590 (South of White Point Swash).

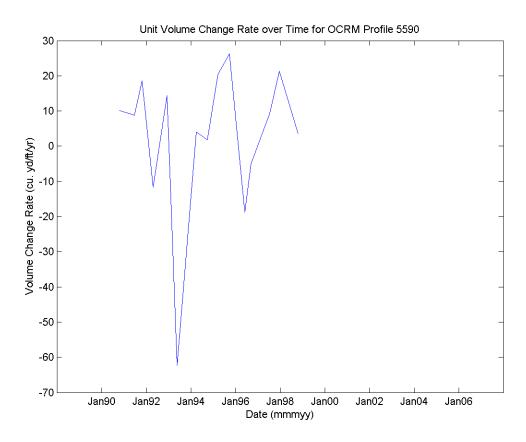
Figure 8-39: Unit Volume Change Rate (cu.yd/ft/yr) over time at OCRM Profile 5590 (South of White Point Swash).

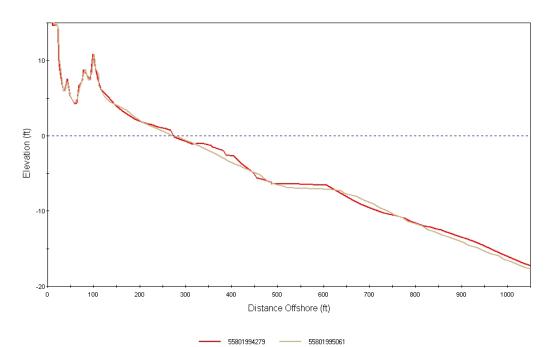
Figure 8-40: Beach profiles south of White Point Swash at OCRM 5580 prior to NMB nourishment project.

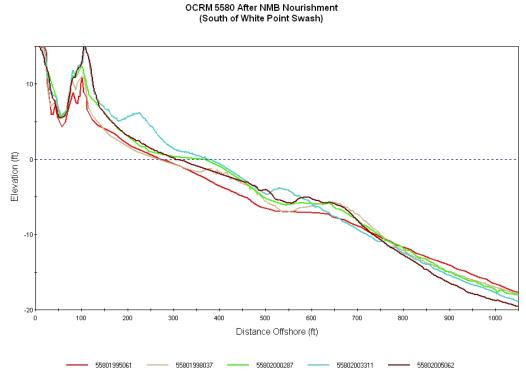
Figure 8-41: Beach profiles south of White Point Swash at OCRM 5580 after NMB nourishment project.

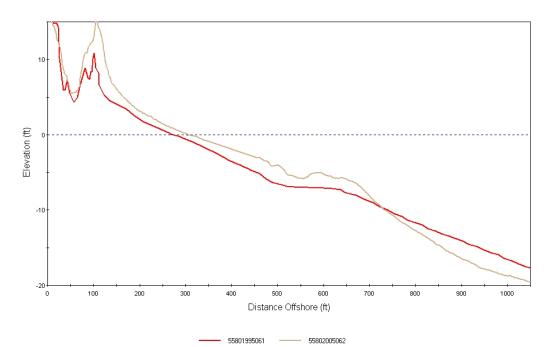
Figure 8-42: Beach profiles south of White Point Swash at OCRM 5580 prior to and after NMB nourishment project.

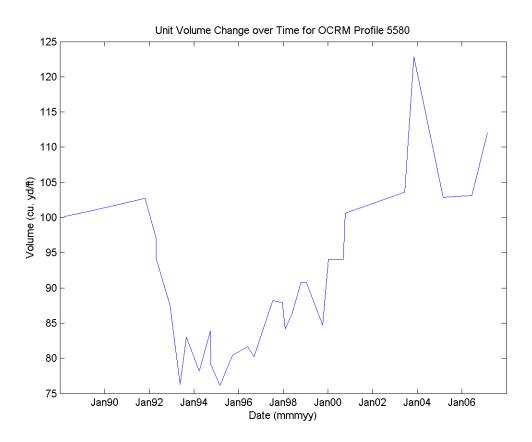
Figure 8-43: Unit Volume Change (cu.yd/ft) over time at OCRM Profile 5580 (South of White Point Swash).

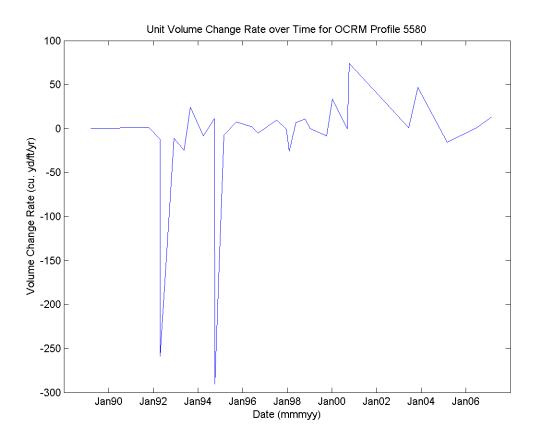
Figure 8-44: Unit Volume Change Rate (cu.yd/ft/yr) over time at OCRM Profile 5580 (South of White Point Swash).

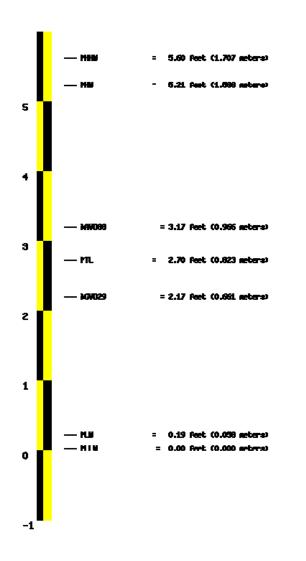
The NHVD 00 and the NGVD 29 elevations related to NLLM were computed from 0ench Mark, 066 1070 J TIDAL, at the station.

Olsplayed tidal datums are Mean Higher High Water(MHHM), Mean High Water (MHM), Mean Tide Level(MTL), Mean Low Water(MLW), and Mean Lower Low Water(MLLW) referenced on 1983-2001 Epoch

Figure 8-45: Benchmark information (vertical datum relationships) for Springmaid Pier.
