FINAL REPORT
FOR:

BRIARCLIFFE ACRES WATER QUALITY STUDY

**PREPARED FOR:
HORRY COUNTY, SC**

January 31, 2011

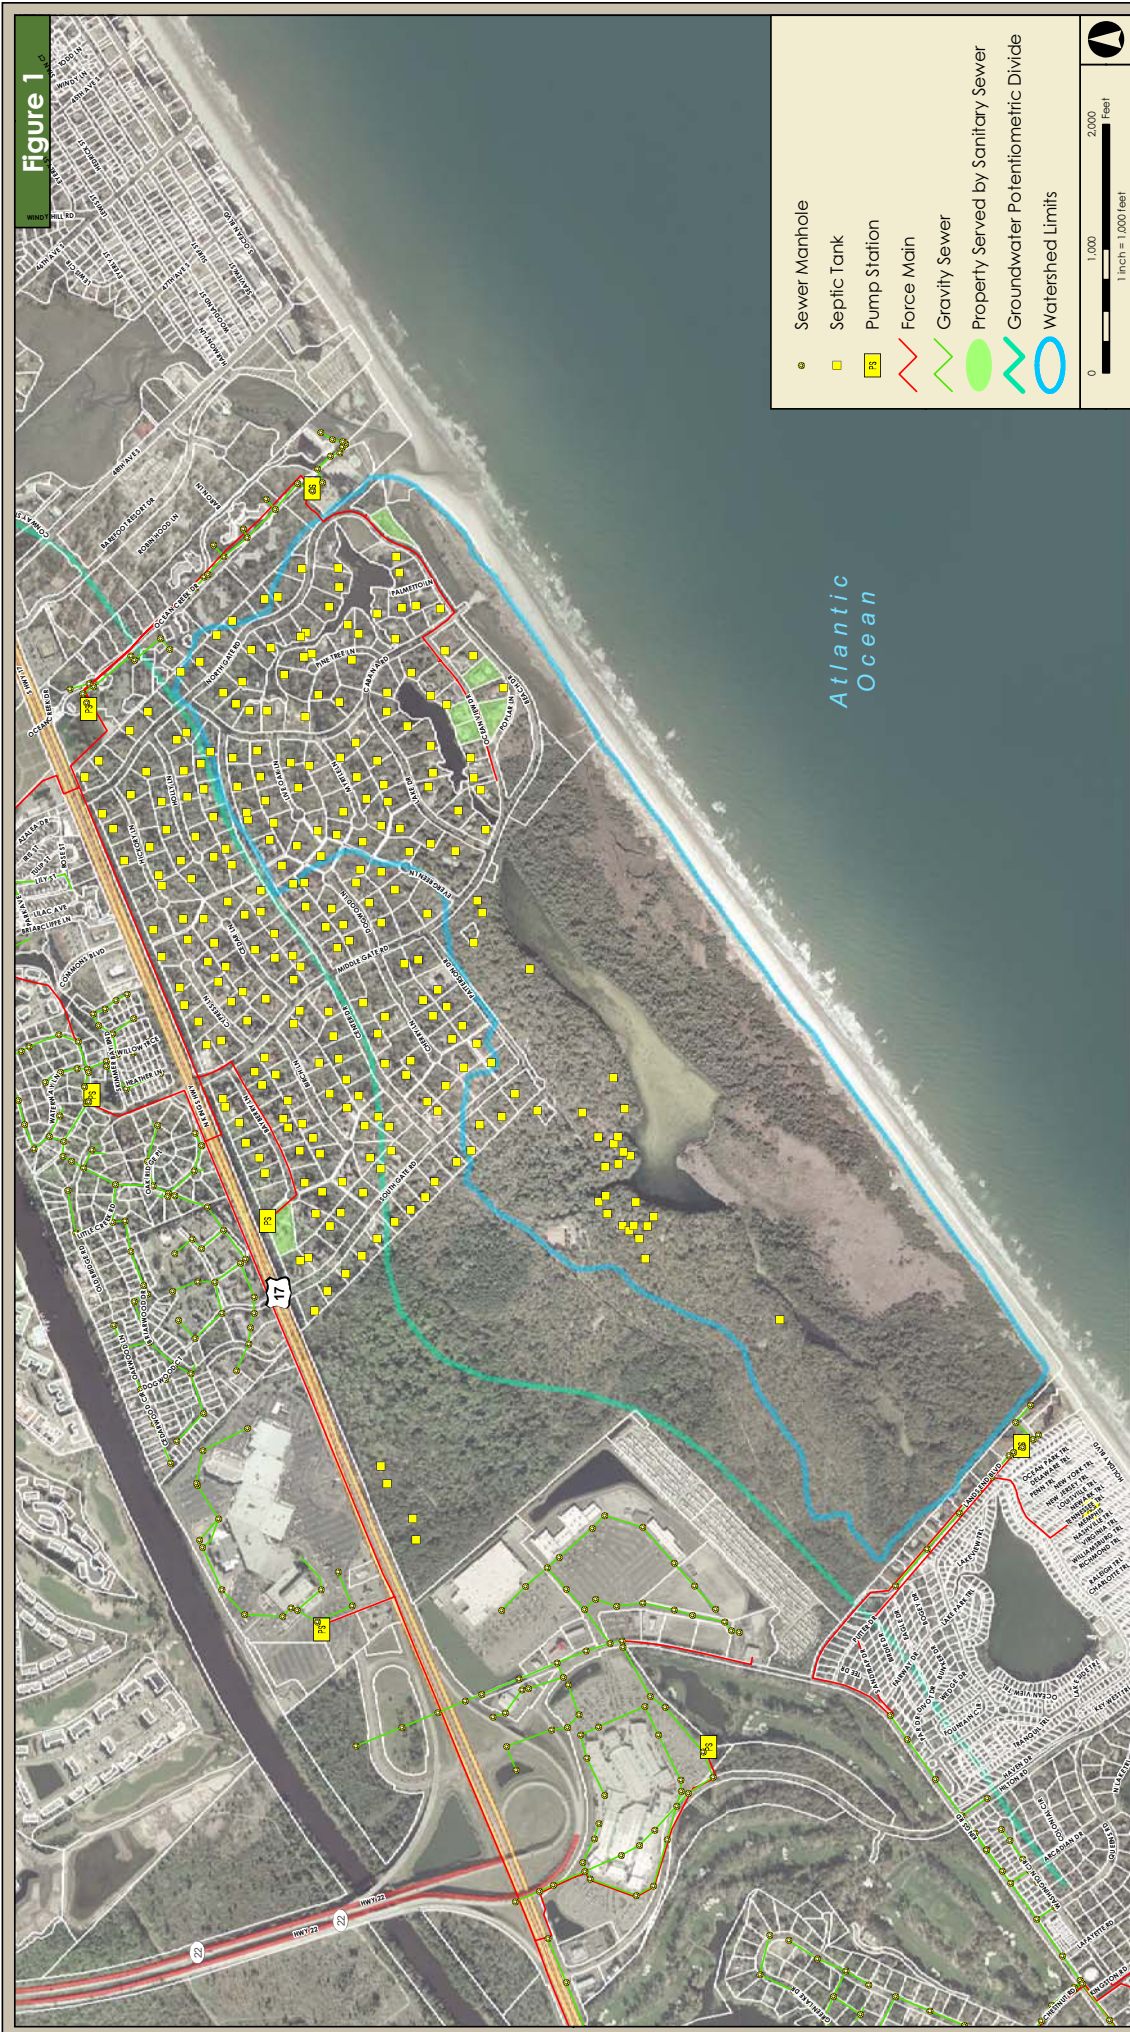
Based on the assumption that all existing homes in Briarcliffe Acres (except those served by with sewer by the City of Myrtle Beach) are served on site by a single septic tank, and the information gathered (and visually confirmed) from the Meher Spiritual Center, the location of known and suspected septic tanks was mapped in the GIS database for the project. Figure 1 illustrates the septic tanks in and around Briarcliffe Acres.

Septic Tank Locations

Approximately 116 septic tank systems are located in the Briarcliffe Acres Swash watershed. In addition to these, approximately 41 septic tank systems are located east of the ground water potentiometric divide. The potentiometric divide was estimated from data collected for 14 monitoring wells on the Meher Spiritual Center site (Various, 1998). Thus, it is possible that septic tank effluent traveling down gradient in the ground water could emerge as groundwater seepage to the Briarcliffe Acres or Meher Spiritual Center lakes.

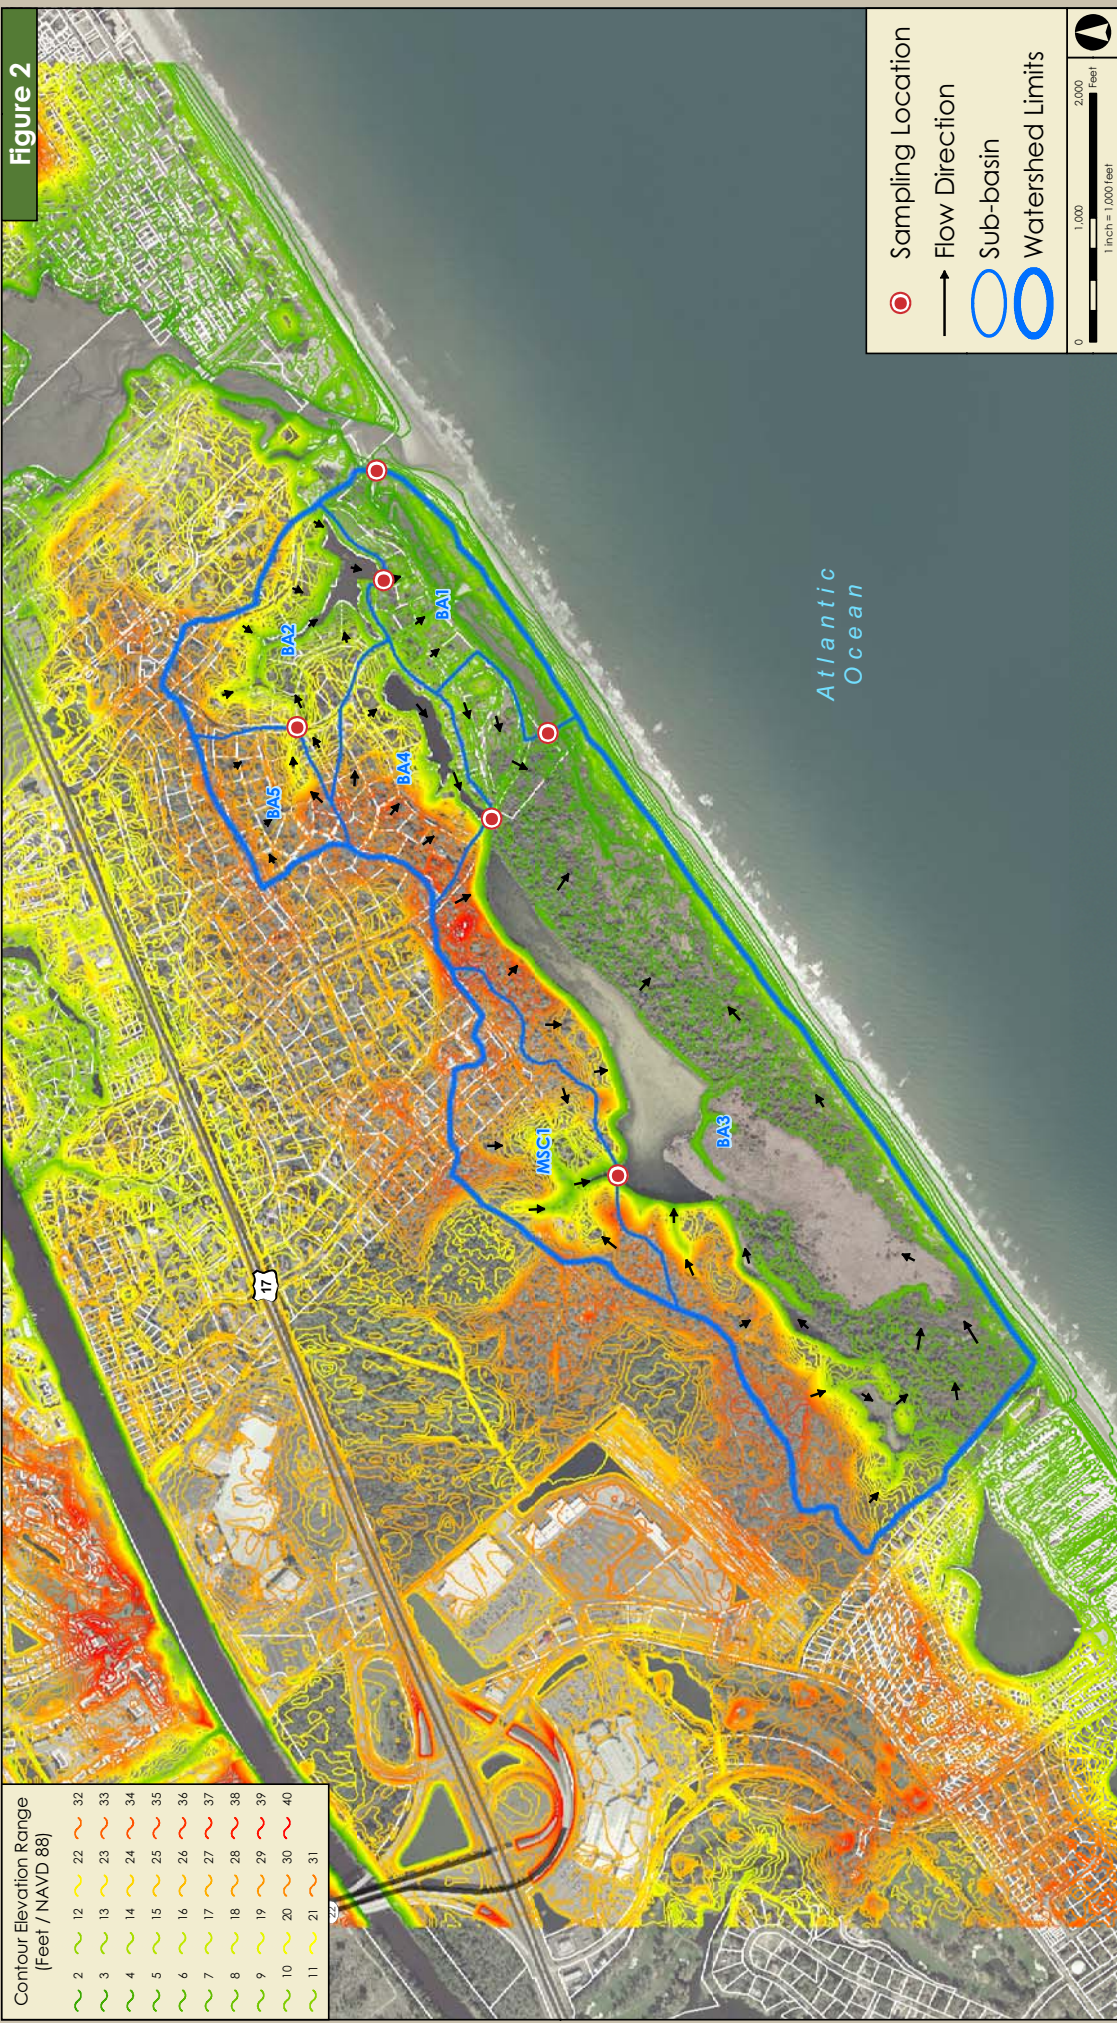
A limited watershed assessment of the Briarcliffe Acres Swash (contributory to White Point Swash) was conducted. Utilizing LiDAR derived 1-foot contours available from Horry County, the total watershed area was delineated. The sub-basins contributing to the six monitoring stations established for this study were also delineated. Table 1 describes the five monitoring stations and their contributing watersheds. Figure 2 is a watershed map of the project area.

Watershed Map

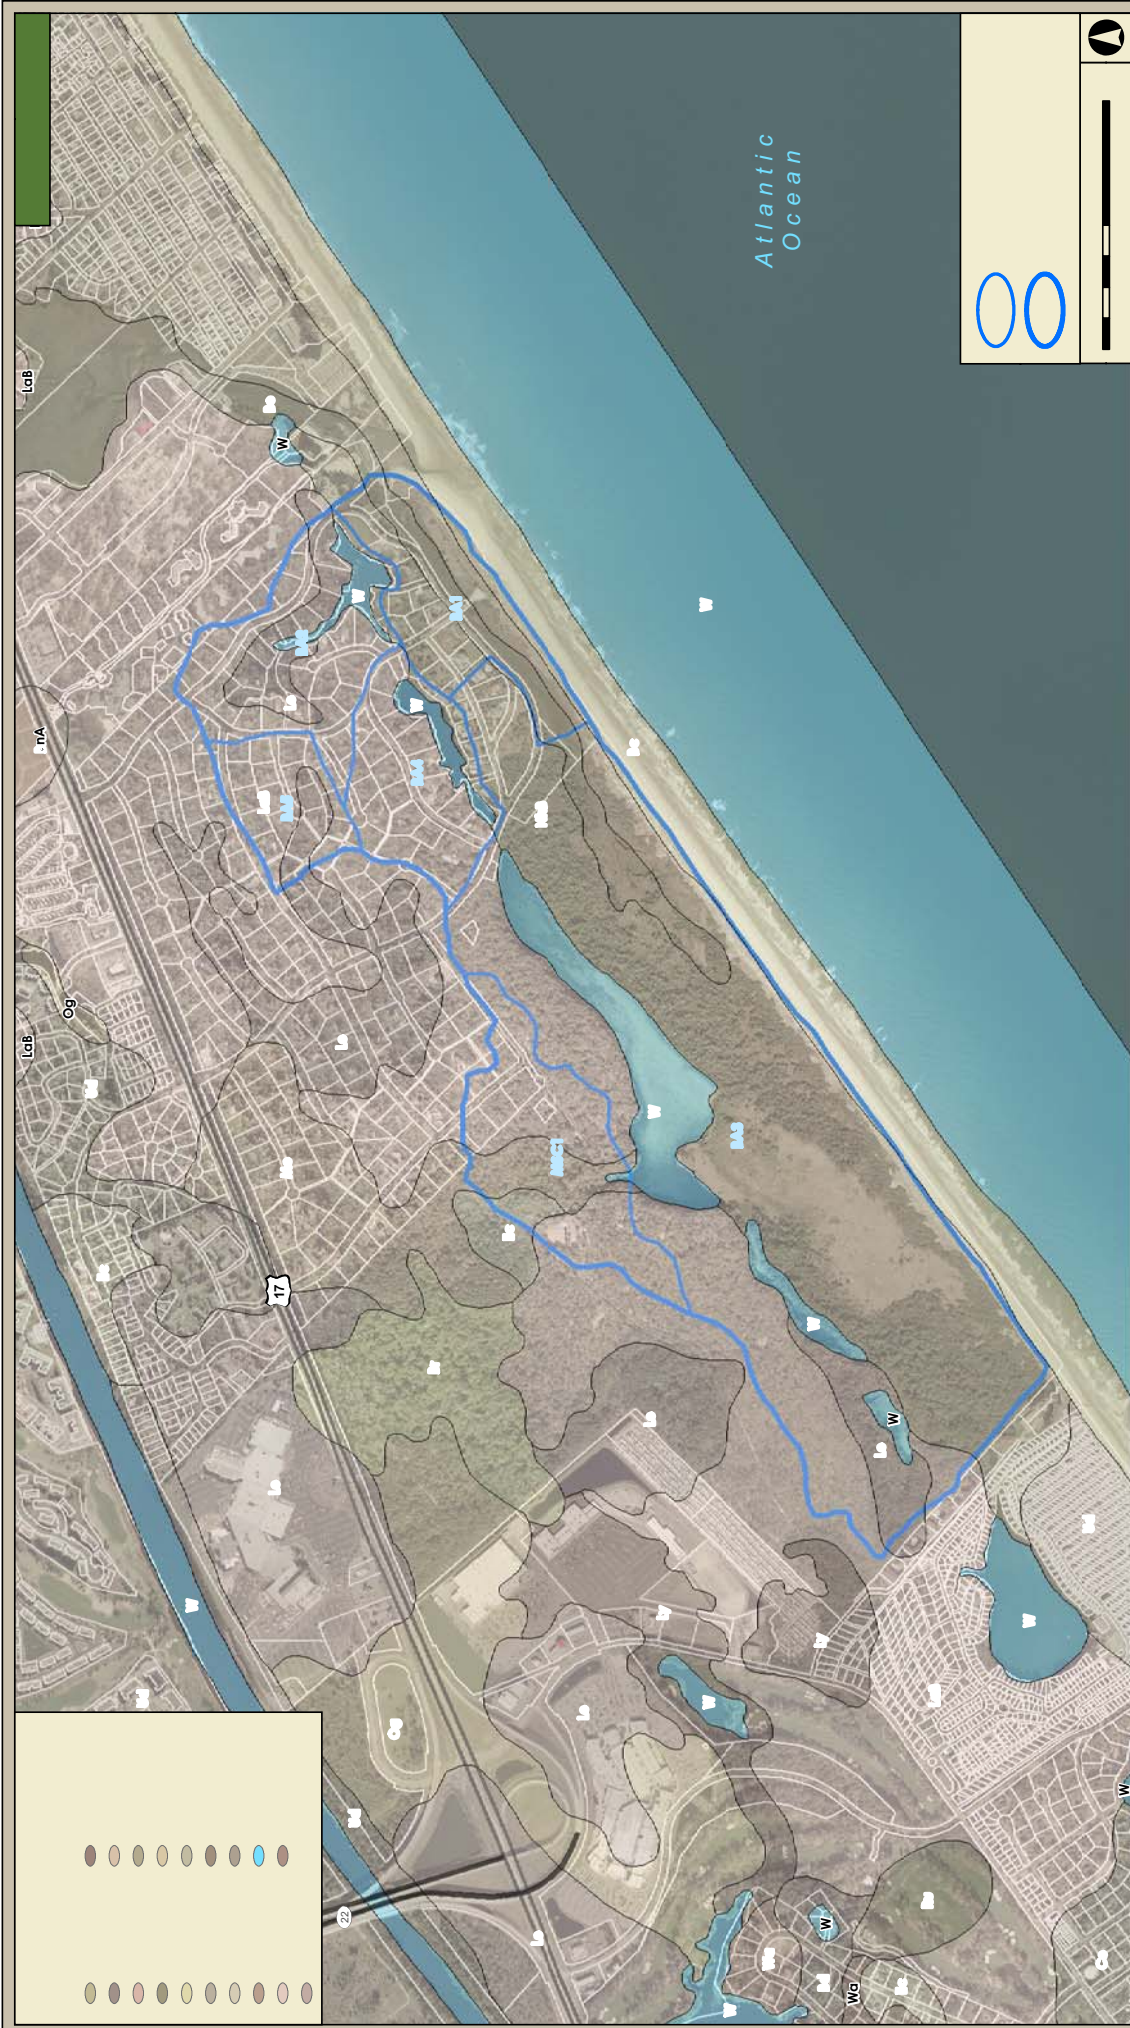
The soils within the study area were assessed. As determined by the National Resource Conservation Service (NRCS), the soils within the Briarcliffe Acres Water Quality Study area are predominantly Newham (Nh) fine sands, Lakeland (a) sand, and Leon (Le) fine sands. Refer to Figure 3 for a soils map of the study areas. Using the NRCS web-based soil survey database (<http://websoilsurvey.nrcs.usda.gov>), soils information for the study area was obtained. Refer to Appendix D for relative soils information from the NRCS.

The Newham, Lakeland and Leon sands are nearly all sand (approximately 95-98%) with a very small portion of silts (2-5%). These soils also have a very high saturated hydraulic conductivity (K_{sat}), ranging from 42 to 141 $\mu\text{m}/\text{sec}$. The Newham, Lakeland and Leon sands are defined as "very limited" for use as septic tank adsorption fields by the NRCS. The reasons given by the NRCS for this are:

Soils Map

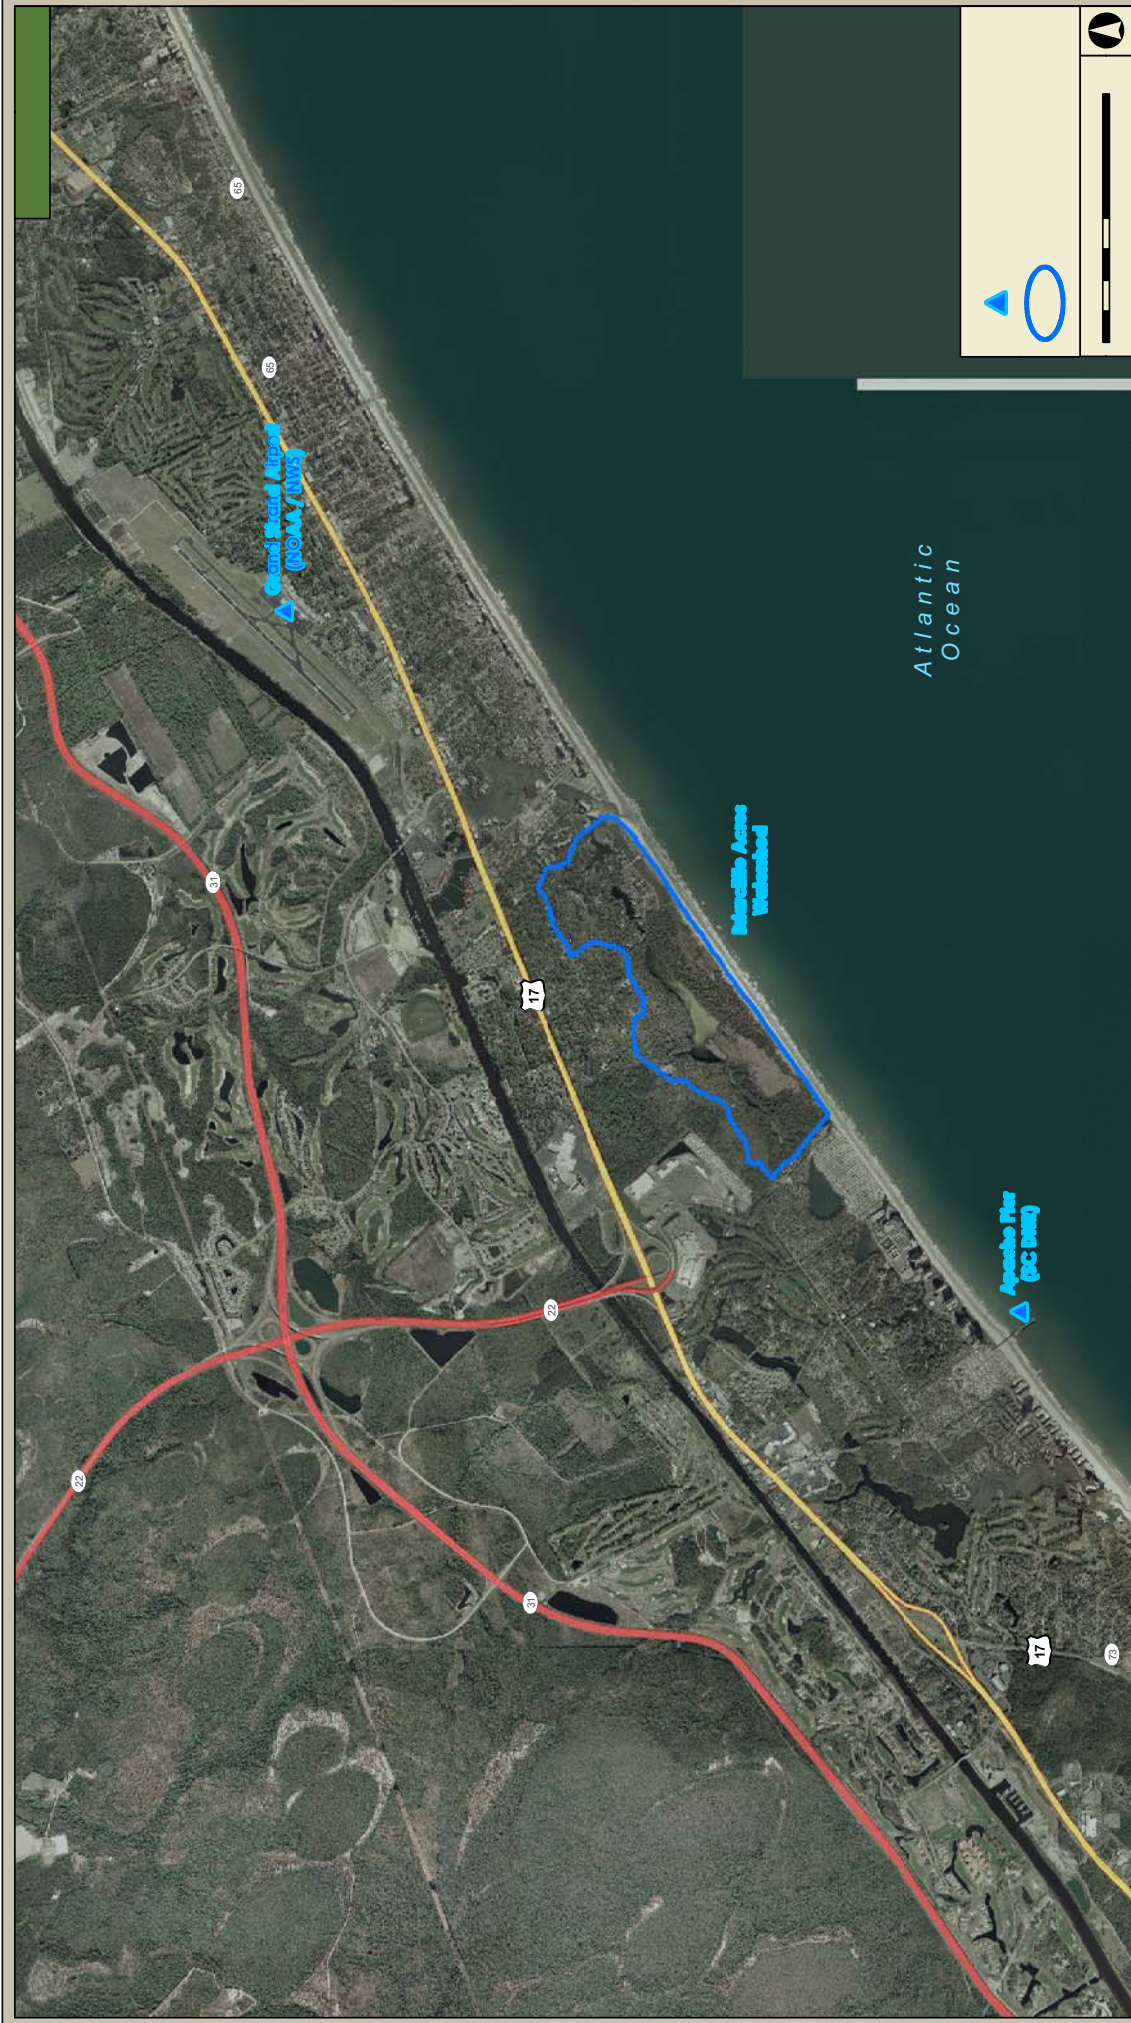
Rainfall totals for local rainfall gages during wet weather events is summarized in Table 3. Refer to Figure 4 for the location of the rainfall gages.

Rainfall Gauges
